CERTIFICATE OF UNEXPLODED ORDNANCE (UXO) CLEARANCE

PROJECT: KIR 43522 – Betio Open Integrated Market

DATE OF CERTIFICATE: 1 February 2024

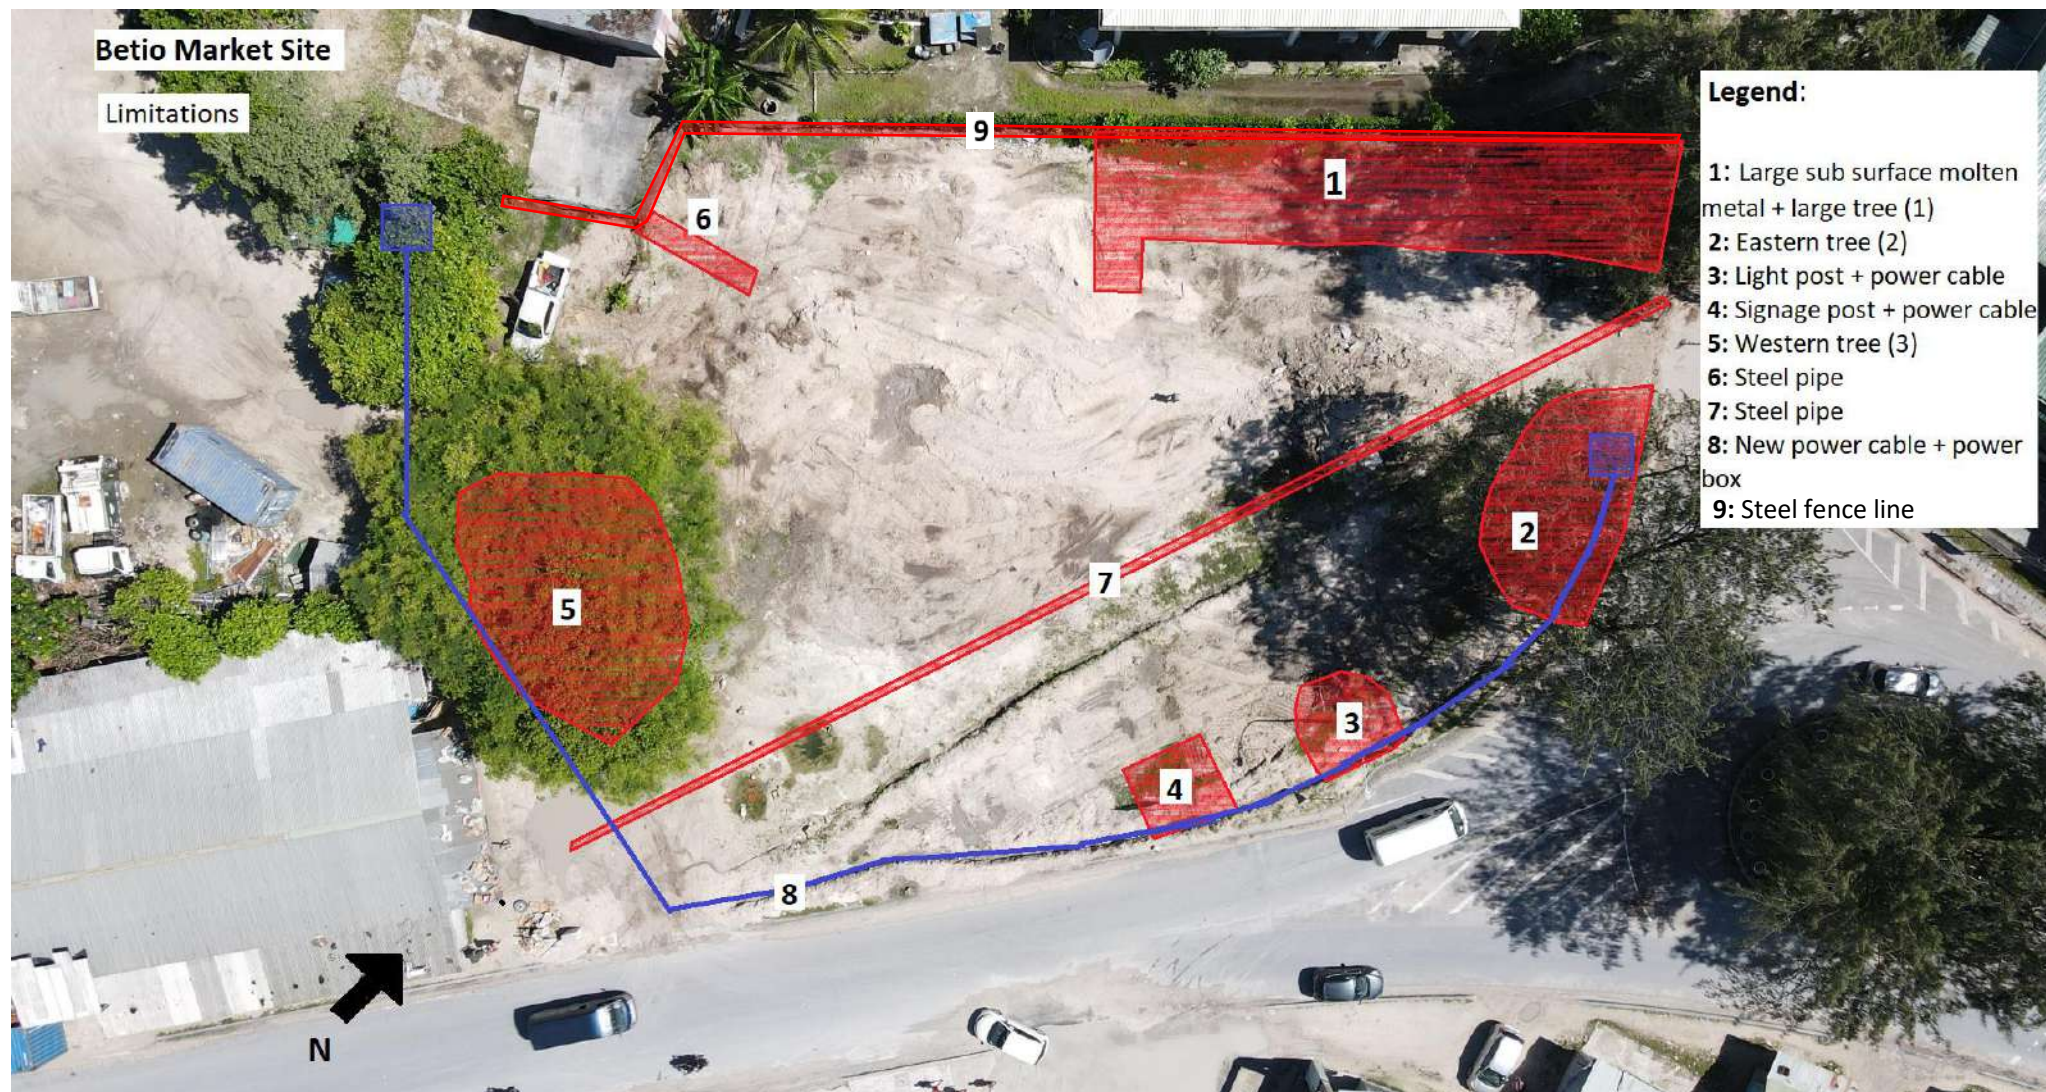
Figure 2: Search Limitation Areas

- An area of approximately 20m x 10m was identified as a limitation due to a large tree/root system together with the discovery of very large quantities of molten metal located in a layer up to 300mm thick. The molten metal appears to be the result of an intense fire. This whole area was excavated and searched to a depth of 500mm. The area below this depth could not be remediated due to the high level of contamination and available equipment (refer area "1" in the attached drawing).

- Large tree along the eastern boundary with substantial/deep tree roots. This area also contains active Public Utilities Board (PUB) electrical infrastructure (refer area "2" in the attached drawing). Tree could not be removed with available equipment/requested to remain in place by the client.

- Existing lighting infrastructure/ steel post. This lighting also has cables running north-east from the base of the pole (refer area "3" in the attached drawing).

- Signage along the boundary near the relocated PUB electrical cables (refer area "4" in the attached drawing).
- Large tree along the western boundary with substantial roots (refer area "5" in the attached drawing). Tree could not be removed with available equipment/requested to remain in place by the client.

- Old steel service pipe running across site was removed during clearance operations, however a section running under the fence line in the northwest corner could not be removed with available machinery (refer area "6" in the attached drawing).

- Existing steel service pipe runs through the middle of the site. This could not be removed with available equipment (refer area "7" in the attached drawing).

- A new PUB electrical cable was installed along the southern boundary of the site. Due to nearby infrastructure and subsurface contamination, these works were conducted under the supervision of a UXO technician (Safety Support). Location of subsurface anomalies within 2m of live cables could not be conducted with confidence due to interference with equipment (refer blue line area "8" in the attached drawing).

- An existing steel fence runs along the northern border of the site. Location of subsurface anomalies within 2m of this fence could not be conducted with confidence due to interference with equipment (refer area "9" in the attached drawing).
- The water table was encountered at approximately 1.5m. Clearance of subsurface anomalies below this depth was not achievable.
- A list of limitations together with coordinates are set out in Tables 2-7. Additional UXO clearance tasks may be required if stated herein.

- The water table was encountered at approximately 1.5m below ground level. Ground intrusive works beyond this depth should be conducted with a UXO Technician providing Safety Support.
- If any of the stated limitations are removed with ground intrusive works to occur, it is recommended that further UXO remediation is performed in these areas or the work is conducted whilst a UXO Technician provides Safety Support.

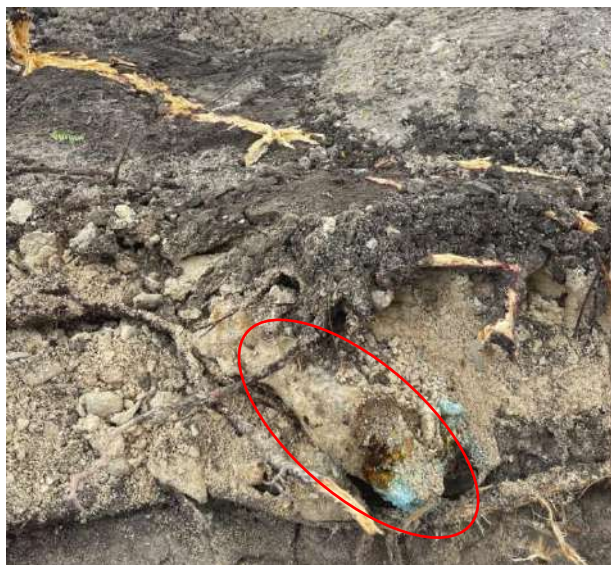
- 1 x US 60mm Mortar M49A2 - 8 December 2023 (#001)

Figure 3: UXO 001 - US 60mm Mortar M49 A2 (08 Dec 23)

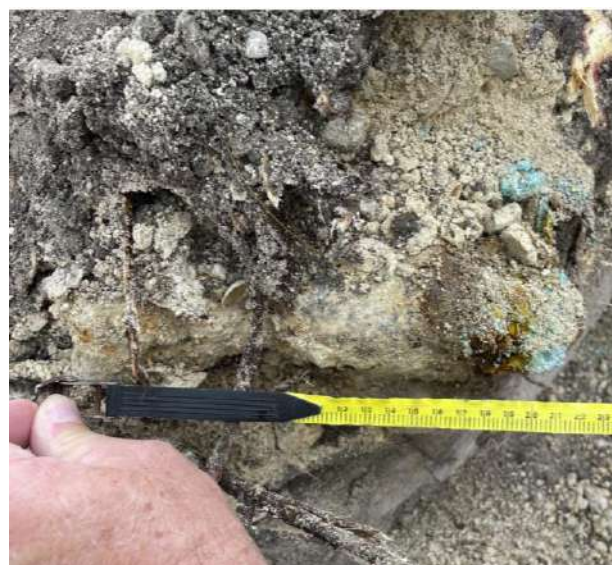
Figure 4: UXO 001 - US 60mm Mortar M49A2 (08 Dec 23)

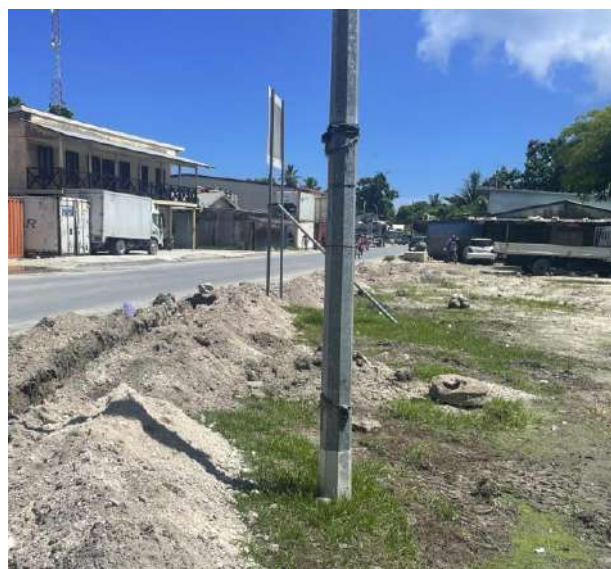
Figure 5: Typical Limitation – Light post, sign and new cable trench (Area 4)

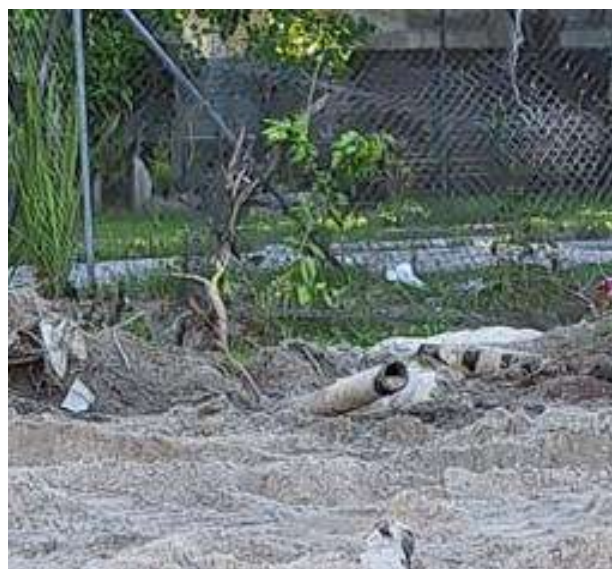
Figure 6: Typical Limitation – Steel Pipe (Area 6)

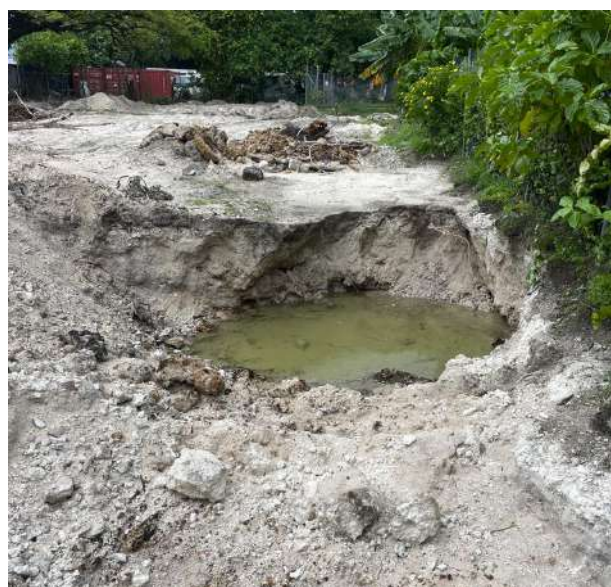
Note that due to site specific limitations, Area 1 was cleared to a depth of 0.5m only.

Figure 7: Typical Limitation – Water Table (Area 1)

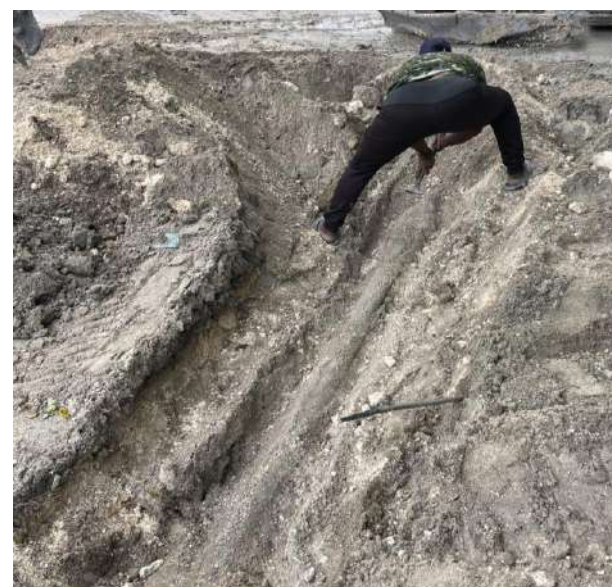
Figure 8: Typical Limitation – Steel Pipe (Area 7)
