**DYNAMIC CONE PENETRATION TEST
REPORT
TEMPORARY OFFICE SHED
MFMRD**

**ENGR. KAIEA COLLINS
MYLANTA SERVICES
Nei Kuae, Bikenibeu, Tarawa, KI**

04 JANUARY 2024

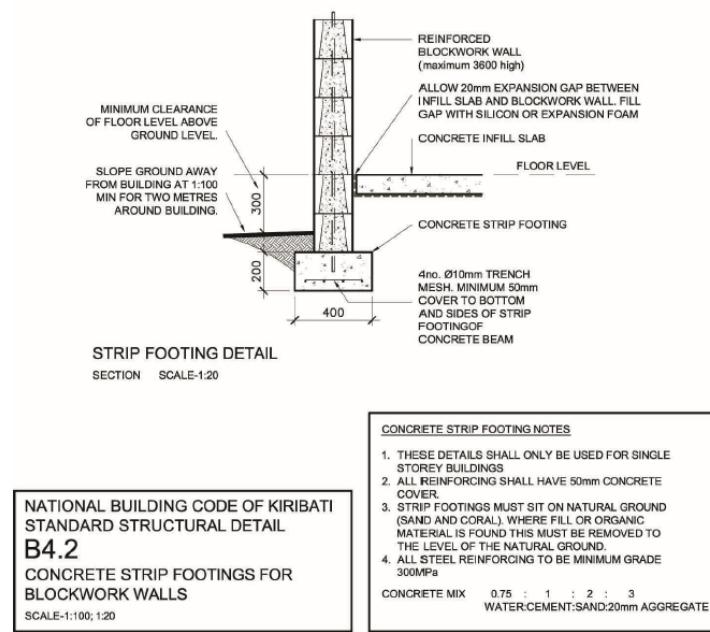
FIGURE 1: STRIP FOOTING STANDARD STRUCTURAL DETAIL (KNBC, 2016)

Unless the current proposed raft footing system has been analysed and designed according to AS 2870-2011, the footing shall be maintained. Otherwise, the following foundation design standard from the Kiribati National Building Code 2016, (KNBC) shall be adopted, Figure 1. This is one of the minimum shallow footing standards designed in accordance to AS 2870-201, which applies to double storey residential and small sized offices and the like classified as Class 2 under the Building Code of Kiribati.

Conversely, the pier footing is 1.5 meters below the surface. In this case, it is strongly advised that a competent engineer perform a proper structural analysis and design so that the pier footing can be modified in accordance with the site's specifications.

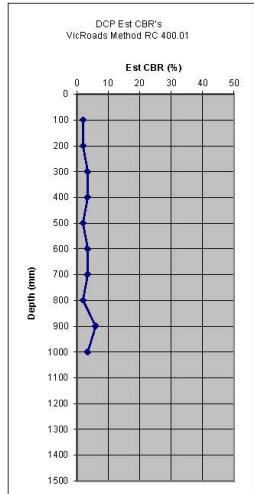
Spot # 11
Location

The minority of the ground conditions are generally considered suitable for the proposed design, which will not impose any significant geotechnical constraints. However, the weak subsoil layers encountered at Spot # 3-6, 11-15, 19 and 30 will require densification to form suitable subgrade material for the proposed design.

Densification of subsoil at Spot # 3-6, 11-15, 19 and 30 is crucial. It is recommended that the sites are proof rolled using a heavy (minimum of 14 tonne deadweight) vibrating smooth drum roller (if available), alternatively uses vibro-compacting plates. Any areas that show signs of excessive deformation during compaction should be continually compacted until deformation ceases, or

alternatively, the weak materials be removed and replaced with suitable structural filling, compacted at every 100-150 mm layer using a plate compactor until footing depth is reached.

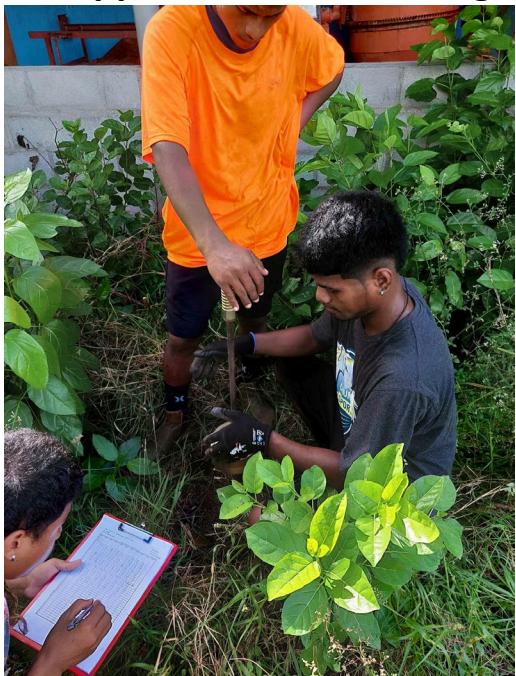
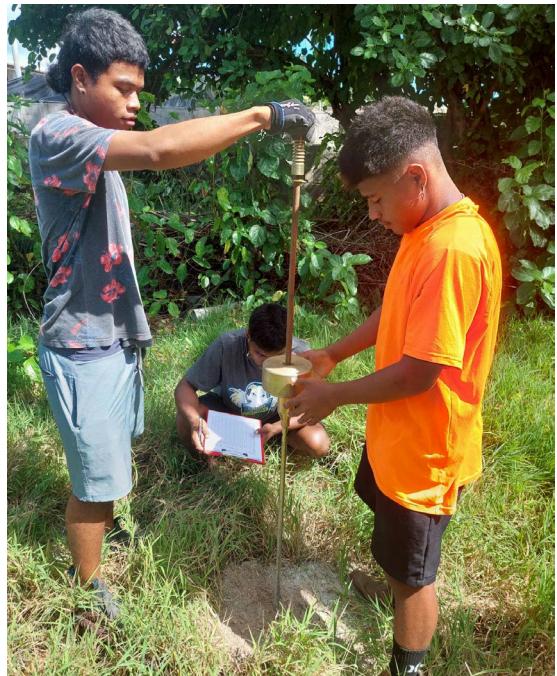
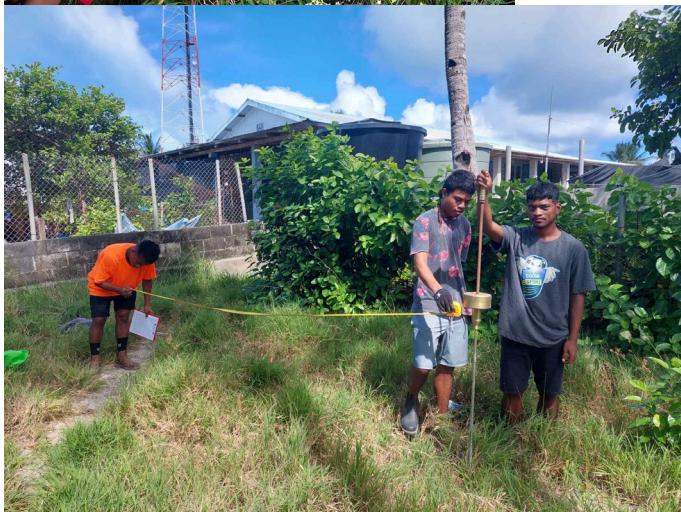
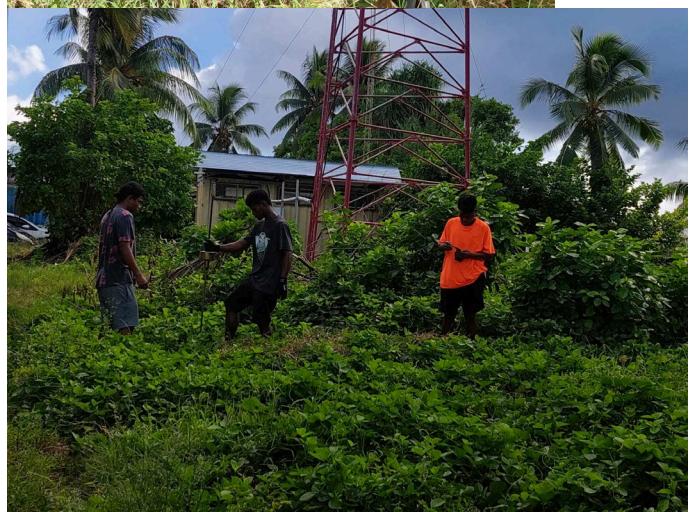
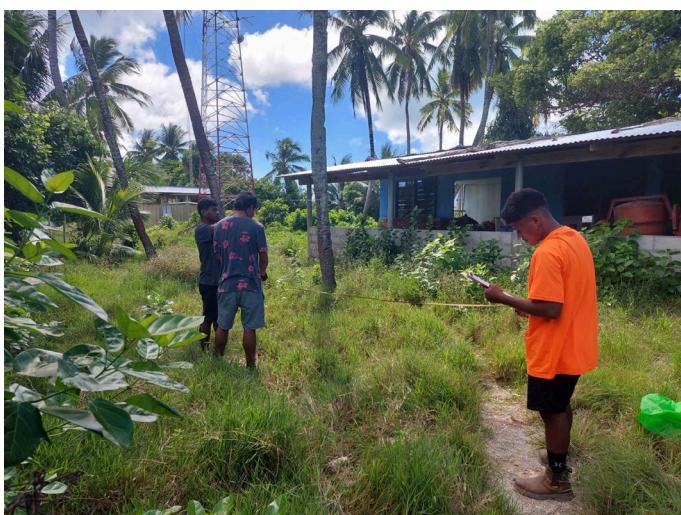
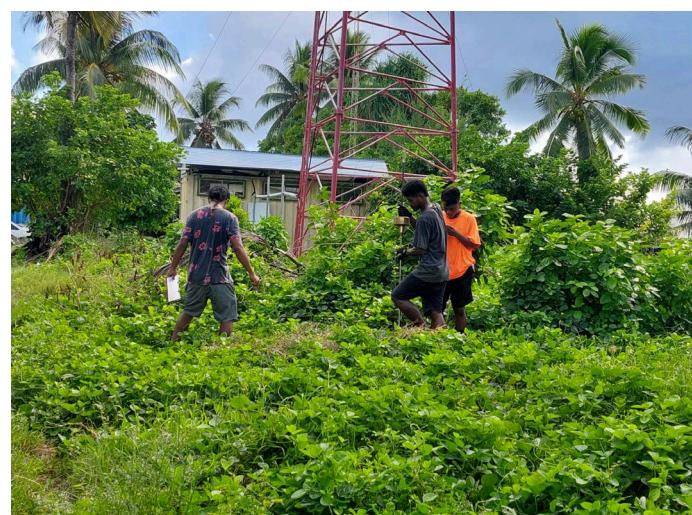
4.4 Appendix 4: Site Photographs

The proposed site is located at Ambo Village, Tarawa. The site is an open field with few vegetation adjacent to a telecommunication tower and an existing old building situated within the proposed structure footprints.

The site's topography is flat surfaced with low field grasses, shrubs and coconut trees. Ground penetration resistance generally vary and are described in section 2.2.2.

All deleterious material, including topsoil and vegetation should be stripped from building envelopes. Up to 7 numbers of coconut trees were identified to be stripped. Topsoil could be re-used for landscaping purposes only.

Tree roots remaining from any clearing operations within the proposed building envelopes should be completely removed and the excavation backfilled with material of similar geotechnical properties to the surrounding ground and compacted to achieve a penetration index equal to or greater than three (≥ 3) blow/100 mm.
